Attachment A: Digital Images

September 2nd, 2008

BOE Building 23rd Floor Wide Post Mitigation Assessment
Sacramento, CA

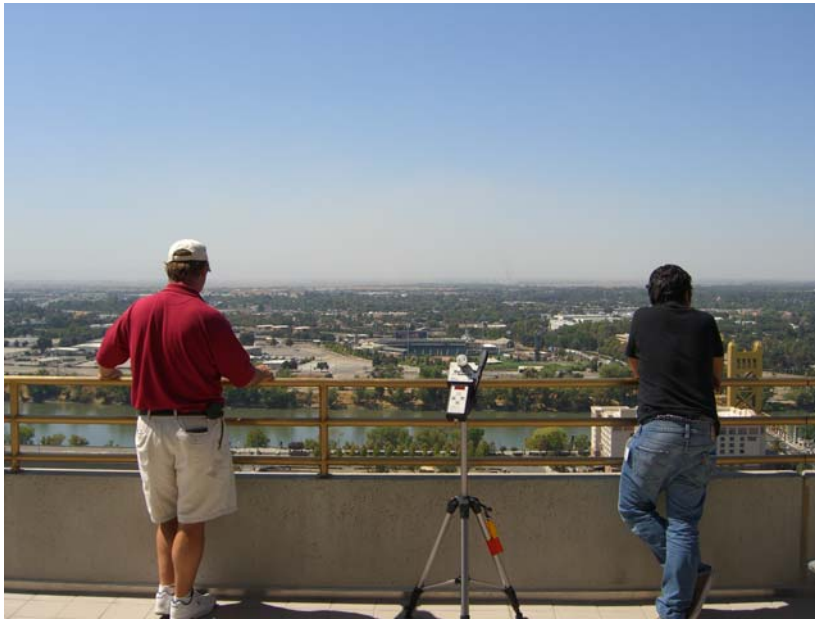
- 1) Image of ambient air sampling location on West side of 23rd Floor Balcony located at 450 N Street, Sacramento, California (Subject Building) at time of assessment.

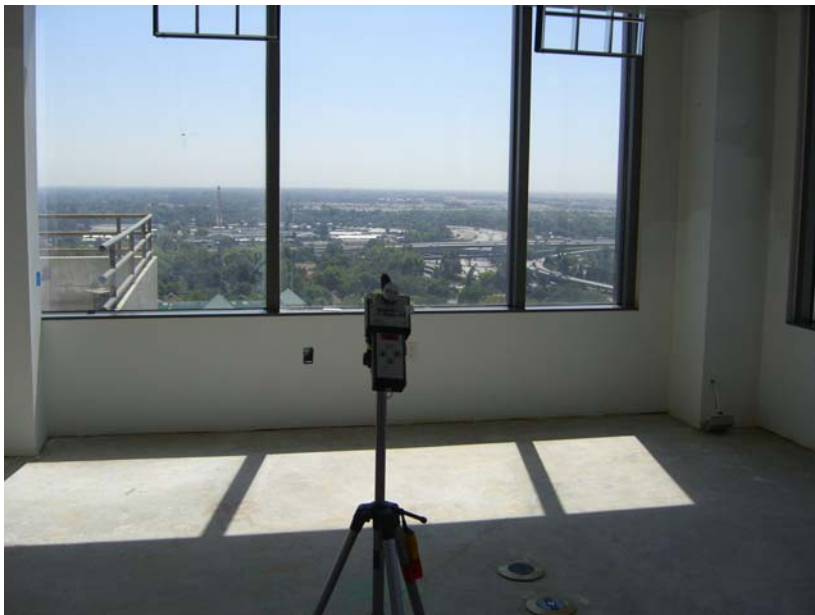
- 2) Image of air sampling performed within southwestern corner of 23rd floor (office 2309) at time of clearance inspection and sampling assessment.

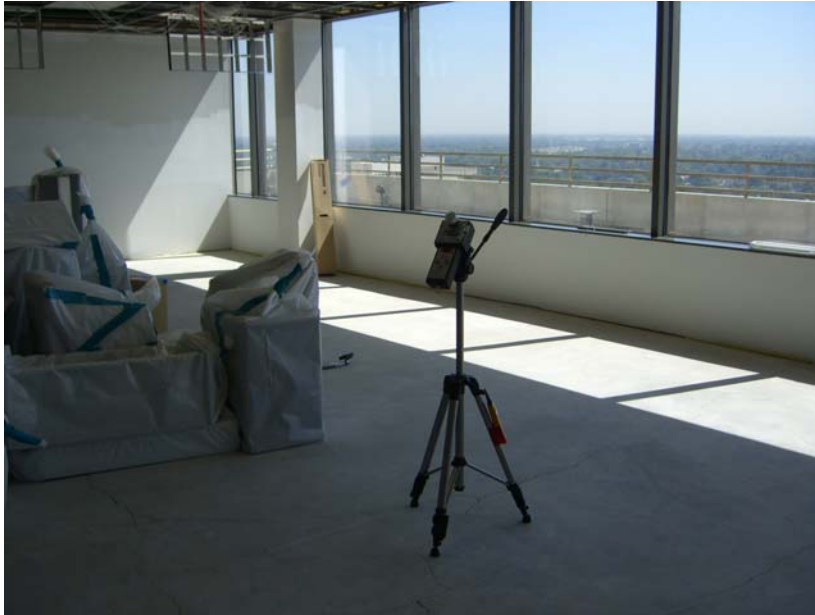
3) Image of air sampling equipment operated within area 2305 at time of assessment.

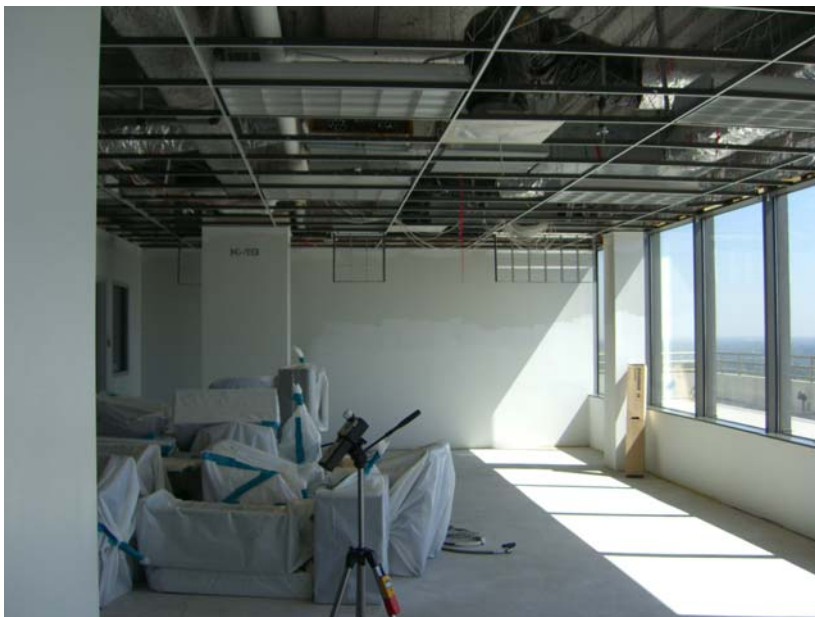
4) Image of physical layout within room 2305 located at center segment of southern perimeter wall within 23rd Floor.

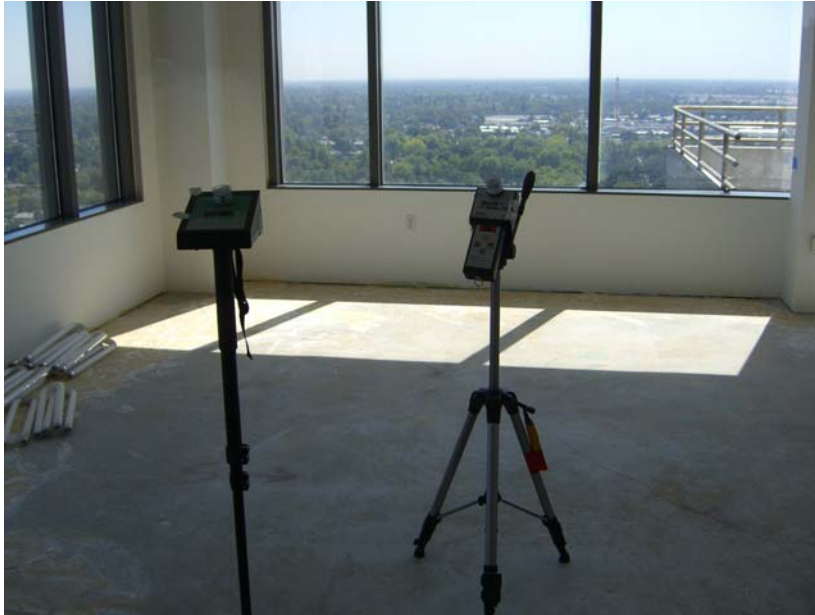
- 5) Image of air sampling activity performed within room 2339 at southeastern corner of 23rd floor at time of assessment.

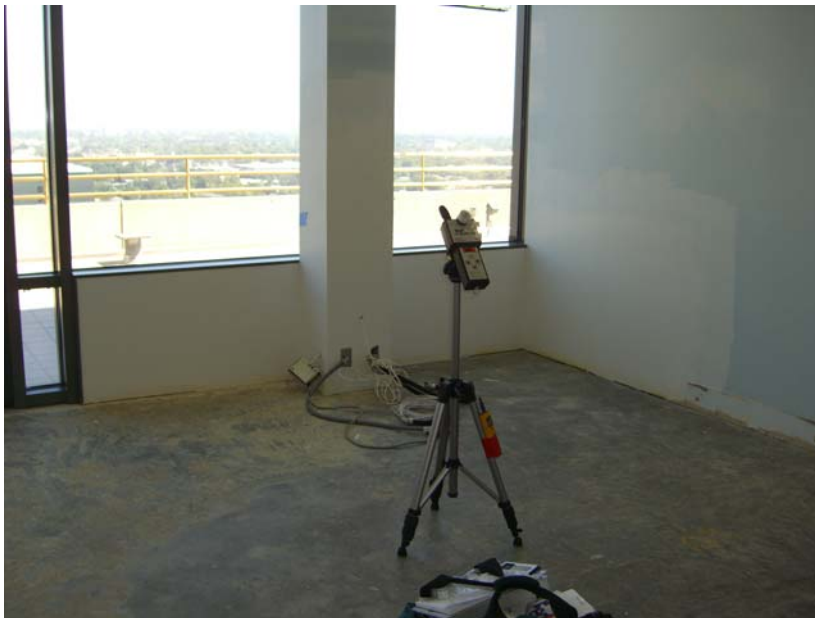
- 6) Image of structures and sampling equipment within office 2335 located along eastern side of 23rd floor at time of assessment.

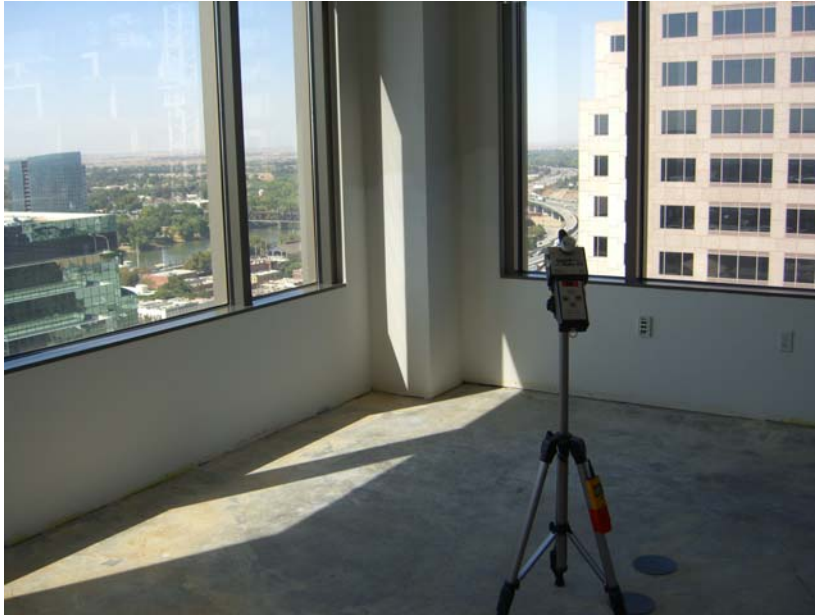
- 7) Image of structures and sampling equipment within office 2332 located along northeastern corner of 23rd floor at time of assessment.

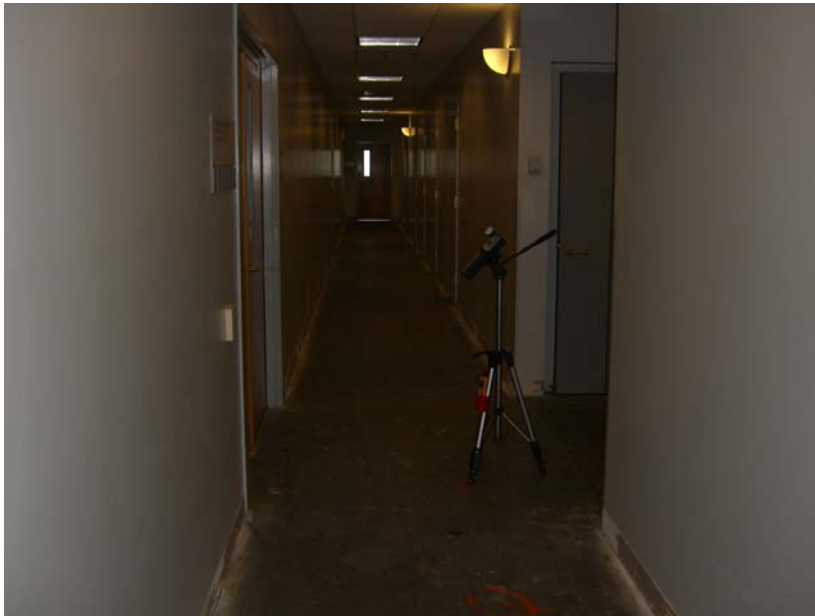
- 8) Image of air sampling performed within northern hallway of 23rd floor of subject building at time of assessment.

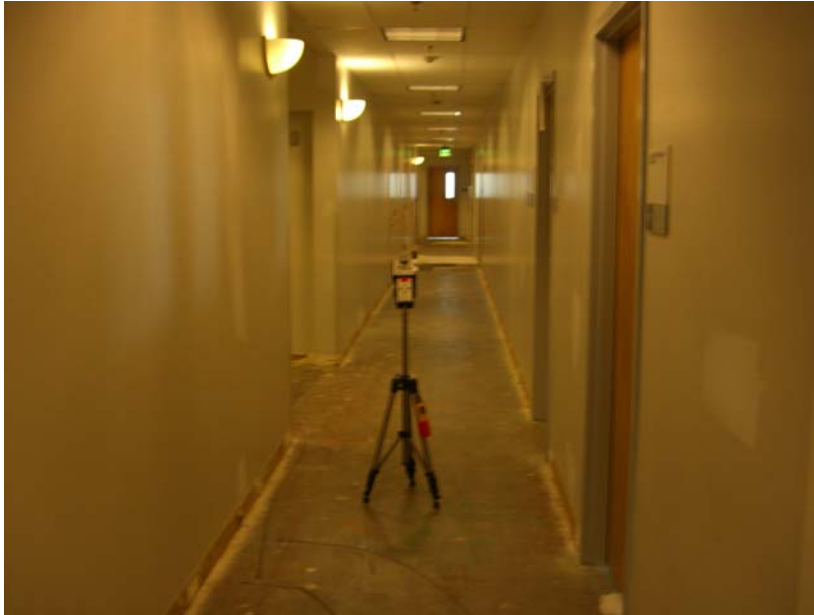
- 9) Image of air sampling performed within south hallway of 23rd floor of subject building at time of assessment.

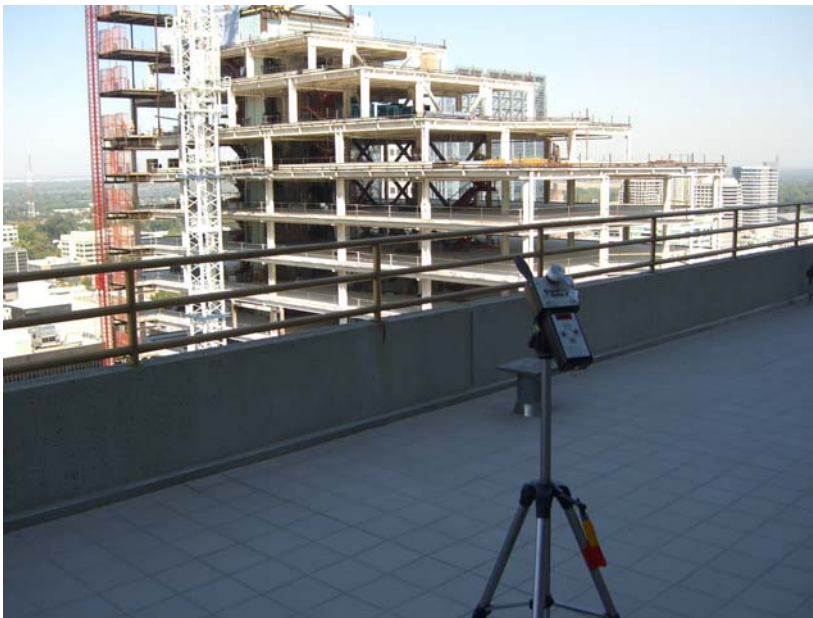
- 10) Image of ambient air sampling performed on northern balxony of 23rd floor at time of assessment.
